Manhole Inspection Summary

Manhole # S29G__023MH

Location Address: **10 s arch st**

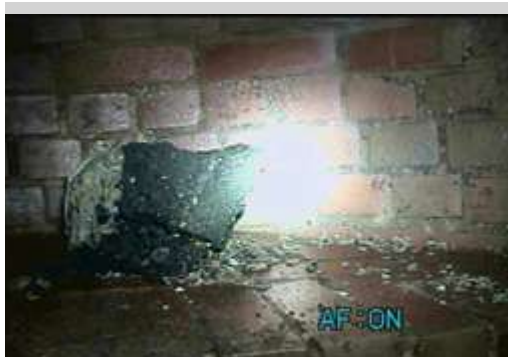
Miscellaneous

bench debris

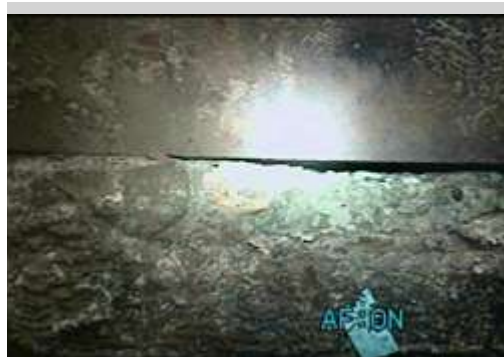
Defect 3

Condition: ☐ Sound ☐ Cracked ☐ Root Intrusion ☒ **Loose Brick** ☒ **Deteriorated**

chimney loose bricks and deteriorated,
frame adj

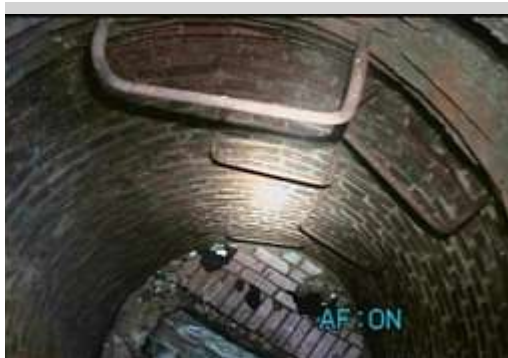
Defect 2

Count: **5** Missing: **0** ☒ **Corroded**

steps

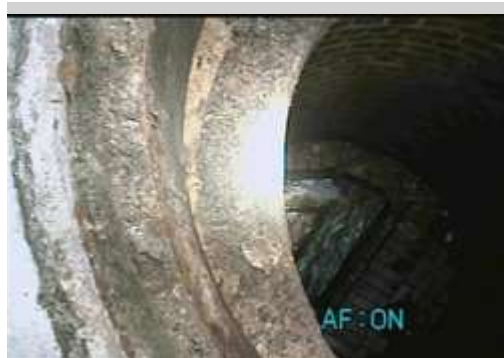
Defect 1

Offset: **4** (in.)

offset
